## Status of nuclear power plants in Fukushima as of 21:00 March 25 (Estimated by JAIF)

# Status of the Nuclear Power Plants after the Earthquake

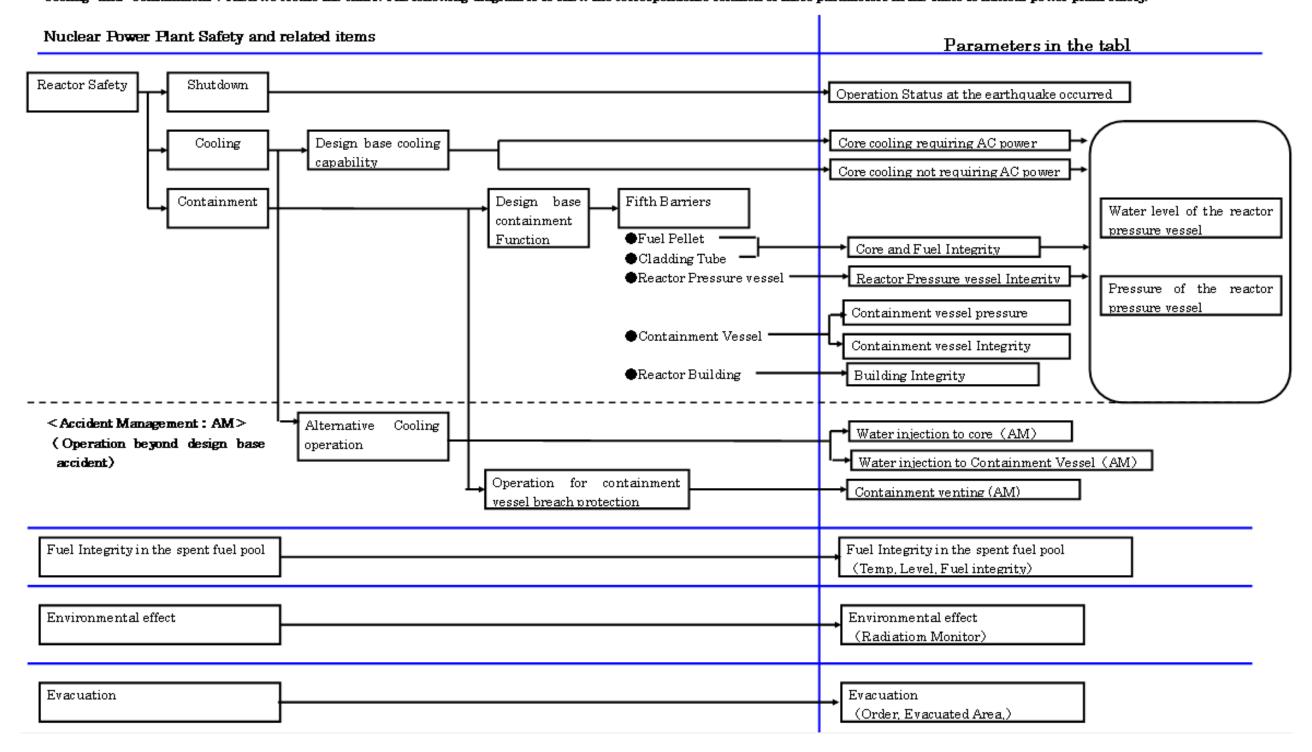
JAIF picks up these parameters to evaluate safety condition of the nuclear plants during this accident from the view point of the principles of nuclear power plant safety, which are "Shutdown", "Cooling" and "Containment". Then we create the chart. The following diagram is to show the correspondence relation of these parameters in the table to nuclear power plant safety.
